THE RESTORATION OF THE REFORMED CHURCH OF AITON 2018–2020 CASE STUDY, CONDITION SURVEY BY FACILITY CONDITION INDEX

Dr. Márton István Bulbuk *¹✉

*¹ Civil Engineer, Conservation Engineer, Conins Ltd, Miercurea-Ciuc, Romania

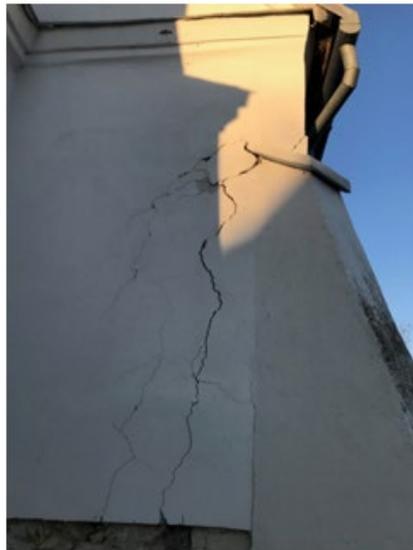
Figure 2: Structural crack in the wall caused by the subsidence of the base of the pillar due to the wet, clayey soil

2.3 $D = 3 \quad C_3 = 7$ Cracks in the walls, caused by Subsidence of foundations.

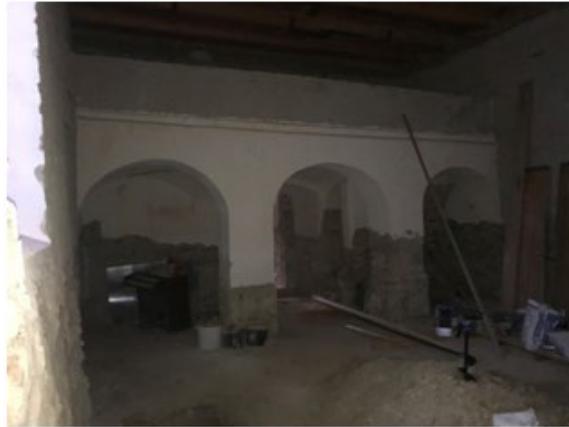
The survival of the southern wall is due to a pair of metal anchors running along the vault and gallery of the inner balcony, as well as owing to the walls of the side entrance and the semicircular masonry of the old sanctuary.

Figure 3: Western choir vault ring beam with double metal bracing

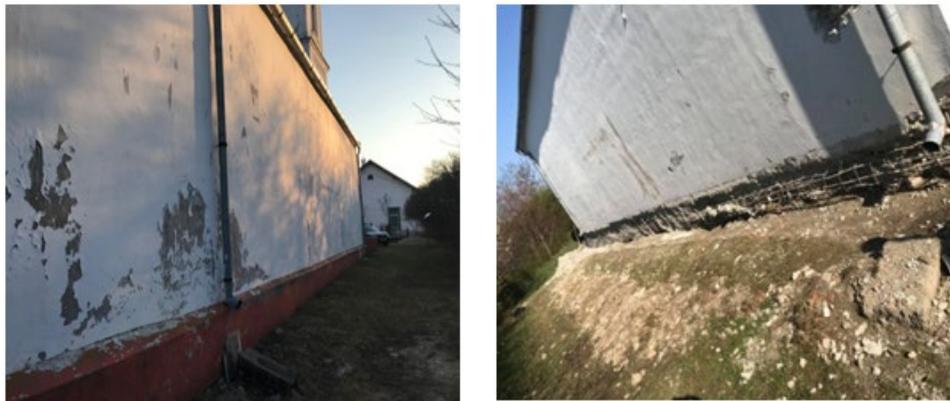
Figure 4: Absorption of moisture in the walls as a result of cement mortar and steel mesh reinforced concrete cladding

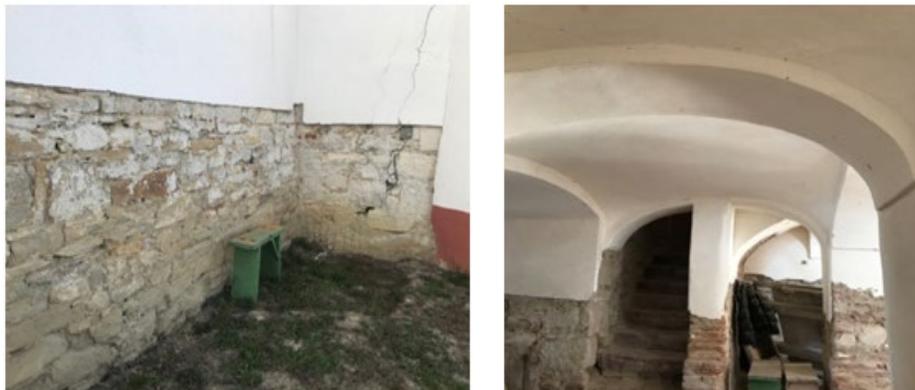
Figure 5: Soaked stone walls and dry-stone walls, 2 years after the removal of rendering
