FIRE SAFETY COMPLIANCE AMONG HOSPITAL BUILDINGS: A CASE STUDY FROM NEPAL-ASIA

Design/Methodology/Approach: The study confined to the 4 hospitals from Bharatpur Metropolitan, Nepal based on judgmental sampling viz; Bharatpur Hospital, BP Koirala Memorial Cancer Hospital, College of Medical Science and Chitwan Medical College building. Literature review was done followed by observation with checklist, questionnaire survey and key informant interview.

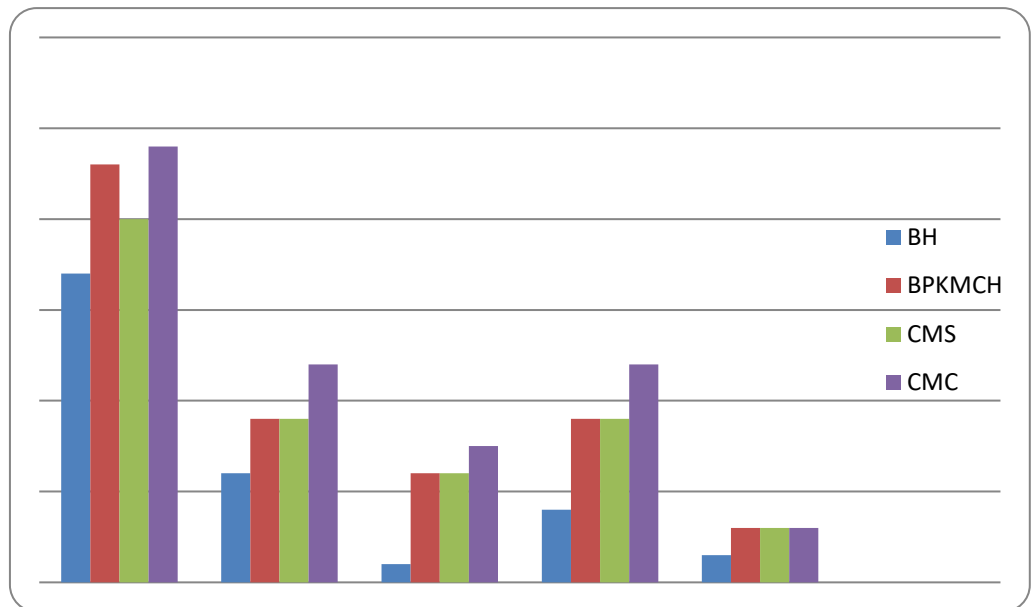
Figure 3 Fire Fighting Equipment Available

The required number of firefighting equipment was not found in the study. So, the total number was counted and compared with each other. Figure 3 reveals that all hospital building had most of the firefighting systems and all lacked the sprinkler system. Bharatpur hospital had less number of firefighting equipment among the selected hospital. Whereas the Chitwan Medical College had highest number among all. The status has somehow similar in commercial building of Birtamode Mishra and Aithal (2022), Lama and Mishra (2022) and Kathmandu Mishra and Shrestha, (2017).
