COMPARATIVE EVALUATION OF MICROLEAKAGE IN ALKASITE AND GLASS-HYBRID RESTORATIVE SYSTEM: AN IN-VITRO

Aim: To Compare and evaluate the microleakage of newly introduced Glass Hybrid restorative system(Equia Forte) with alkasite based restorative material(Cention N).

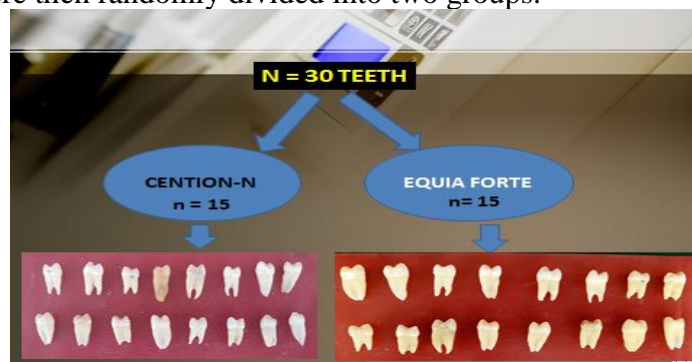
Figure 1: 30 premolar samples

30 premolars free of caries or any other defects and extracted for orthodontic reasons were chosen for the study (Fig 1). All specimens were cleaned and stored in distilled water till use.

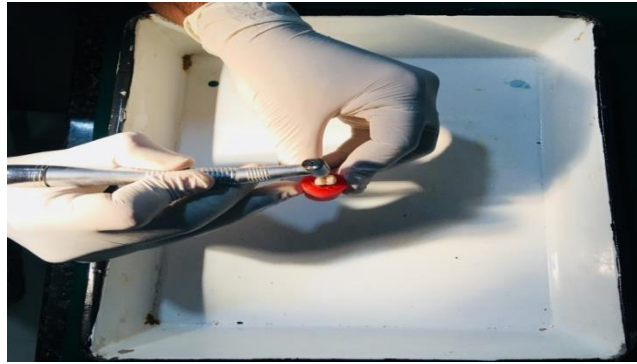
Figure 2: standardized class I cavity preparation

Standardized Class I cavities were prepared, approximately 4 mm in length, 2.5 mm in width and 3 mm in depth. Diamond burs (#837 Komet Gebr, Brasseler, Lemgo, Germany) were used in a high speed handpiece to prepare the cavities, under constant water irrigation [5]. A William's graduated periodontal probe (Hu-friedy, Chicago, IL, USA) was used to measure the dimensions of the prepared cavity. The teeth were then placed in distilled water at room temperature until use. All prepared samples were then randomly divided into two groups.

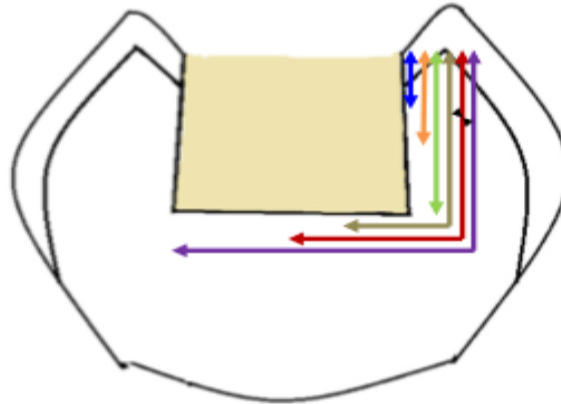
Figure 2 Schematic diagram depicting levels of microleakage.

Score 0	No dye penetration
Score 1	Dye penetration up to 1/4th buccal and lingual wall
Score 2	Dye penetration up to 1/2 of buccal and lingual wall
Score 3	Dye penetration along the entire buccal/lingual wall
Score 4	Dye penetration up to 1/4 th of pulpal wall.
Score 5	Dye penetration up to 1/2 of pulpal wall.
Score 6	Dye penetration along entire pulpal wall.

Figure 3: Scoring criteria for dye penetration [6].

Stereomicroscopic evaluation of the sectioned samples in each group was done and the degree of dye penetration was assessed according to the following scoring criteria [6].

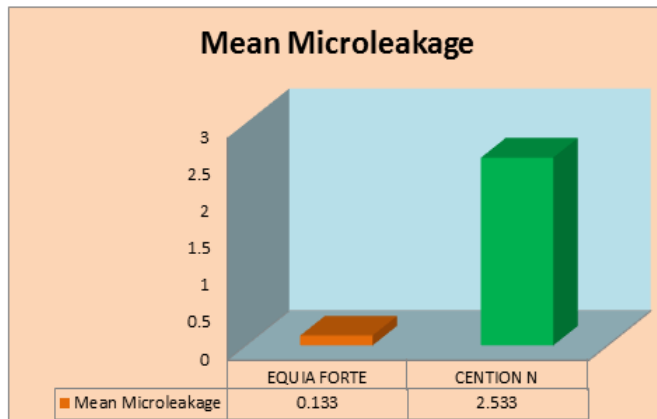
On evaluation, the mean microleakage between two groups was seen to be highest with Cention-N restorations. Equia Forte showed lesser microleakage.

Mann-Whitney U					
	Group	N	Mean	Std. Deviation	p
Mean Microleakage	EQUIA FORTE	15	0.133	0.351	<0.001
	CENTION N	15	2.533	2.166
